Problems with misdiagnosis of Zinc Needles in High Tech Environments

ZINC'S THREAT TO THE DATA CENTER OR CLEANROOM

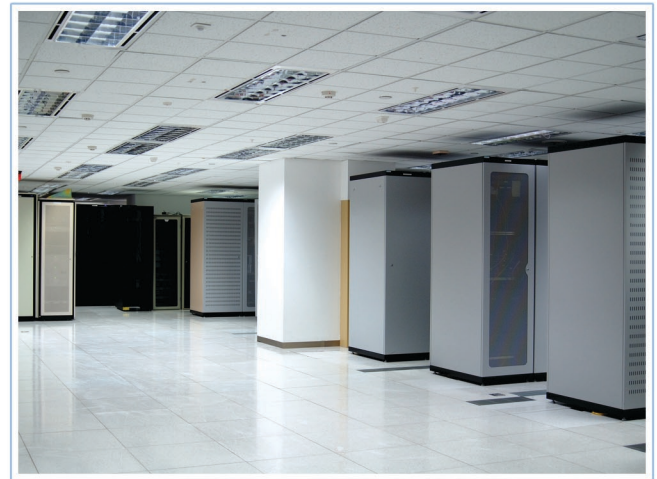
Zinc needles ("ZN") are conductive contaminants that grow in a hair or fiber like formation – they come from cold-dipped galvanized tiles that are stimulated to grow from the constant temperature, humidity, oxygen levels and energy levels within the data center environment. If the back of an access tile was manufactured using the cold-dip electroplated process with a "flat pan" type of backing on the tile, ZN growth will most likely appear eventually. The ZN will appear on the backs of any access floor tiles in an icicle formation.

ZN grow in microscopic proportions - as the crystals grow, like hair, they can eventually break off and spread throughout the facility by the continuous forced airflow within the airflow plenum (the area below the floor tiles) and the forced airflow above it. ZN can then settle inside air-cooled equipment and on any other surface – which has the potential to cause catastrophic downtime, production failures and can actually cause short circuits inside power units and equipment. High quantities of zinc may also contribute to bad indoor air quality and "sick building syndrome". Since ZN can be such a threat, companies are willing to pay high dollar amounts to have this contamination removed (zinc remediation) and chemically retarded to ensure zinc growth has been stopped.

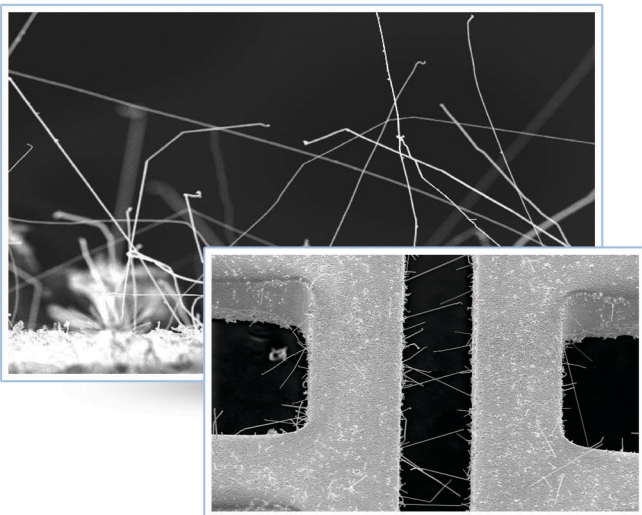
There are three strong indicators that are commonly used to show a potential of ZN growing on the access tiles within the facility.

1. **Manufactured Type/Date:** Cold zinc galvanized tiles have the greatest potential of zinc growth. Typically, the cold zinc galvanized tiles were manufactured before the early 1990's, so it would be good to find a date stamp or manufacturer's model # on the tile (if there is one) and research the manufactured date of the access tile. This would give an indication of whether the tile has a higher potential of zinc needle growth.

2. **Type of Backing on the Access Floor Tile:** Look for a "flat pan" type of backing on the access floor tile. Typically, the flat pan will not have a high shine if it is a candidate for ZN growth. Also, if there are "dimples" throughout the metal on the back of the access floor tile – it may be less likely that the tile will facilitate the growing of ZN.

3. **Shiny Particles:** Place the tile in an area with low light, use a high powered halogen flashlight and shine it on the back of the tile at a slight angle. Although zinc grows at microscopic levels, Zinc has a high shine – so there is a good chance that speckles of shiny particles will be more visible to the naked eye using this procedure. Some even use a low powered microscope to try and see the shiny particles a little closer.
